Manhole Inspection Summary

Manhole # S57E__007MH

Insp Date: **6/30/08 12:43 PM**

Location Address: **4201 e lombard st**

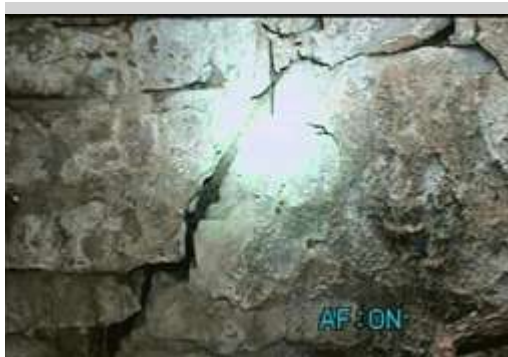
Misc

other side of corbel

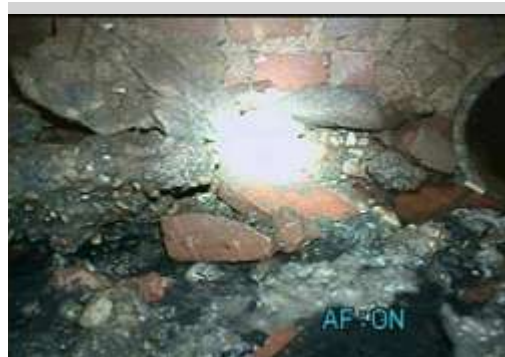
Defect 5

Condition: ☐ Sound ☐ Cracked ☐ Root Intrusion ☐ Deteriorated ☐ Leaks ☒ **Debris**

bench & channel debris

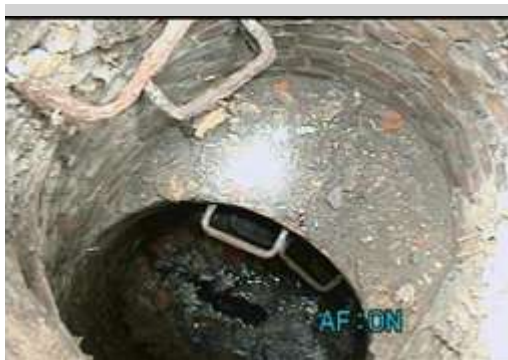
Defect 4

Steps Count: **5** Missing: **0** ☒ **Corroded**

corroded steps

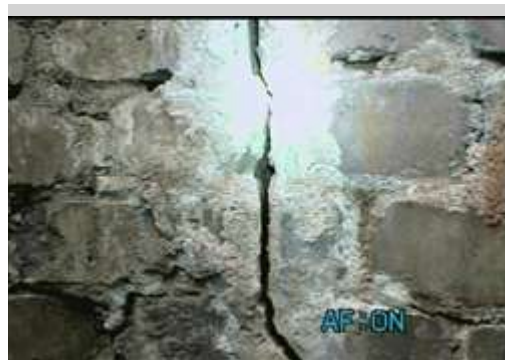
Defect 2

Condition: ☐ Sound ☒ **Cracked** ☐ Root Intrusion ☒ **Loose Brick** ☐ Deteriorated

cracked corbel

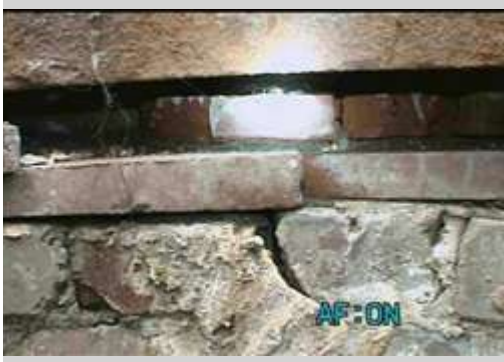
Defect 1

Condition: ☐ Sound ☒ **Cracked** ☐ Root Intrusion ☒ **Loose Brick** ☒ **Deteriorated**

Chimney_Crack_Loose bricks

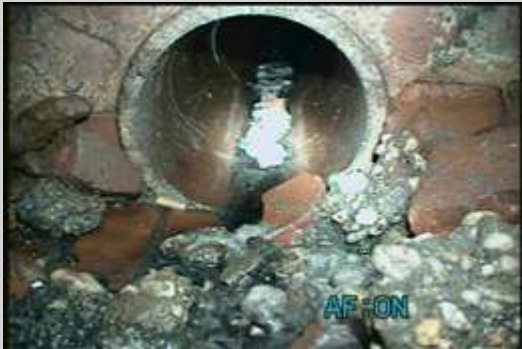
12 O'Clock Outflow

8 in. Circular Gravity Sewer
Pipe Out @ 12 O'Clock

Invert Depth: 11.25 (ft.) Flow Characteristics: **Slow**

Infiltration: **None** Pipe Seal Cond: **Unknown**

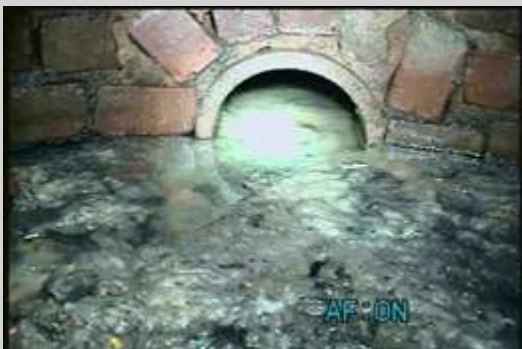
6 O'Clock Inflow

8 in. Circular Gravity Sewer
Pipe In @ 6 O'Clock

Invert Depth: 11.01 (ft.) Flow Characteristics: **Slow**

Infiltration: **None** Pipe Seal Cond: **Unknown**
